Trip Report 2001 Annual Inspection of the Parkersburg, West Virginia, Nuclear Waste Policy Act Section 151(c) Disposal Site

Summary

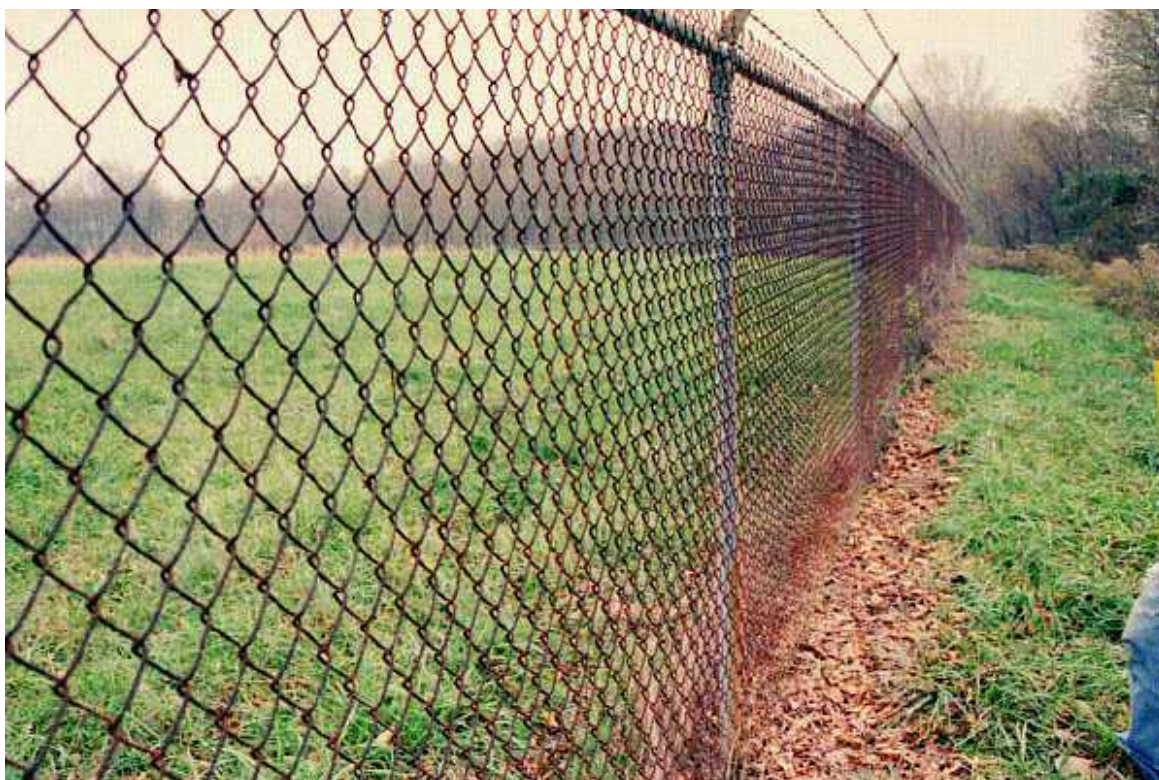
The security fence is in fair condition. Although the fence continues to function as designed, most of the chain link fabric is showing signs of heavy rusting and corrosion (PL-1 and PL-2) due to the humid climate of the region. The chain link fence is now approximately 16 years old. The fence may remain serviceable for another 5 years or more. Once the integrity of the fence is no longer acceptable, the entire security fence (i.e., posts, fabric, top railing, security wire, hardware, etc.) may require replacement. Future inspections should closely monitor the condition of the security fence to determine the optimal time for replacement.

PL 1. Heavy rust on chain link fabric.

Recommendation: During future inspections, inspectors should carry fencing tools and wire to repair breaks found during the inspection. Inspectors should also continue to monitor the overall condition of the fence to determine the optimal time for replacement.

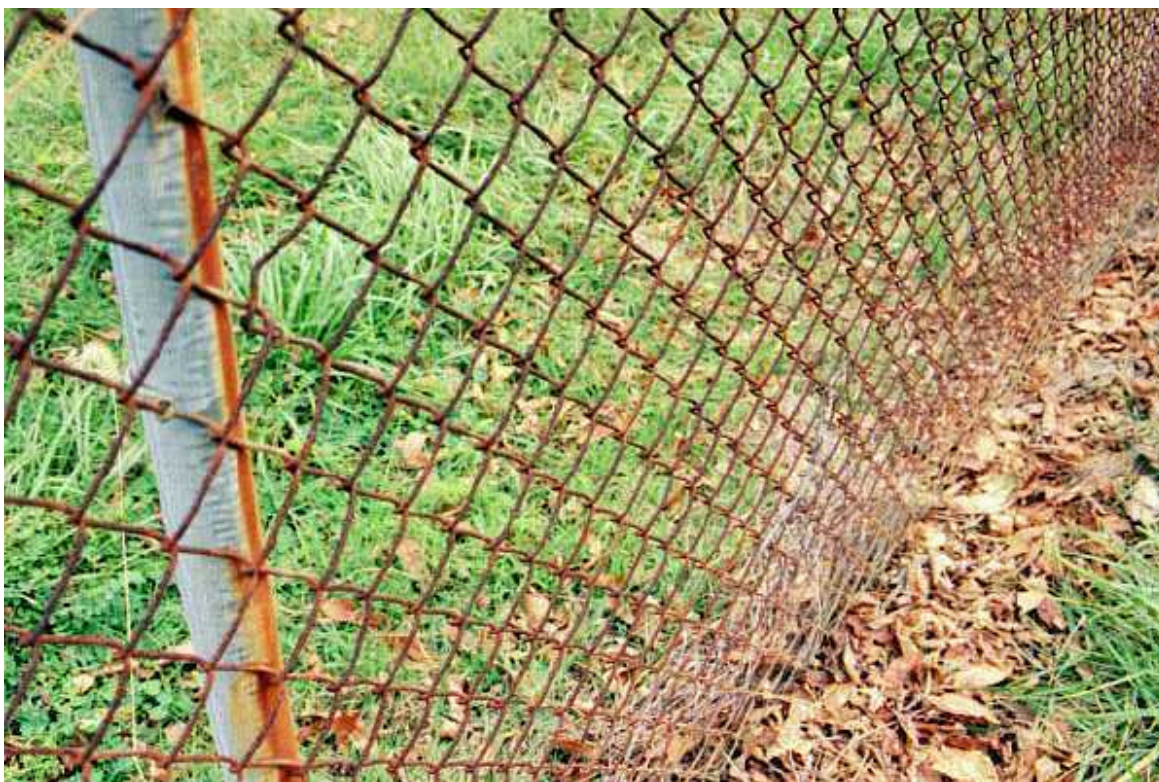
PL 2. Heavy rust on chain link fabric.

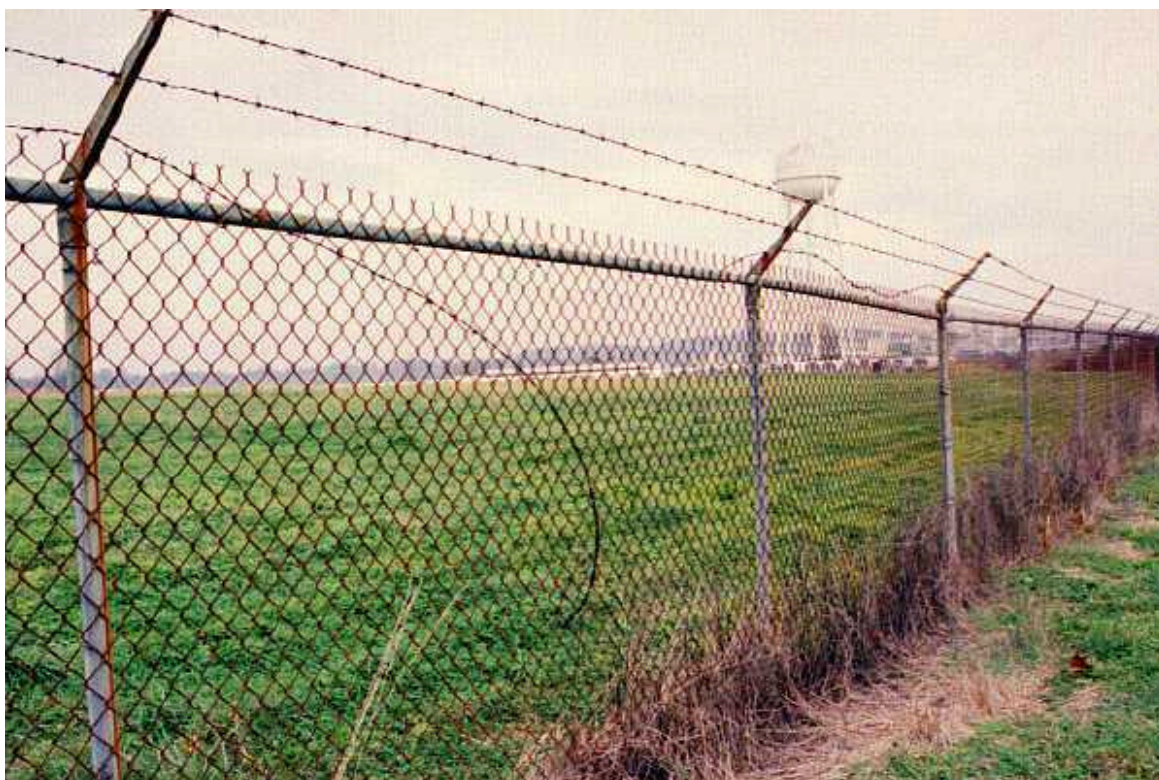
Barbed wire is attached to angle brackets along the top of the entire security fence. Inspectors noted that one of the three strands of barbed wire near perimeter sign P15 had rusted through and broken (PL-3). Generally, the condition of the barbed wire is poor. Inspectors observed severe rusting of the barbed wire at many locations. Apparently, the life expectancy of the barbed wire may be shorter than that of the chain link fabric. Additional breaks in the barbed wire are expected and inspectors should carry fence repair tools and extra wire to repair breaks found during future inspections. The program should consider replacing the barbed wire in the near future, perhaps before other fence components are replaced.

PL 3. Broken strand of barbed wire on top of security fence.

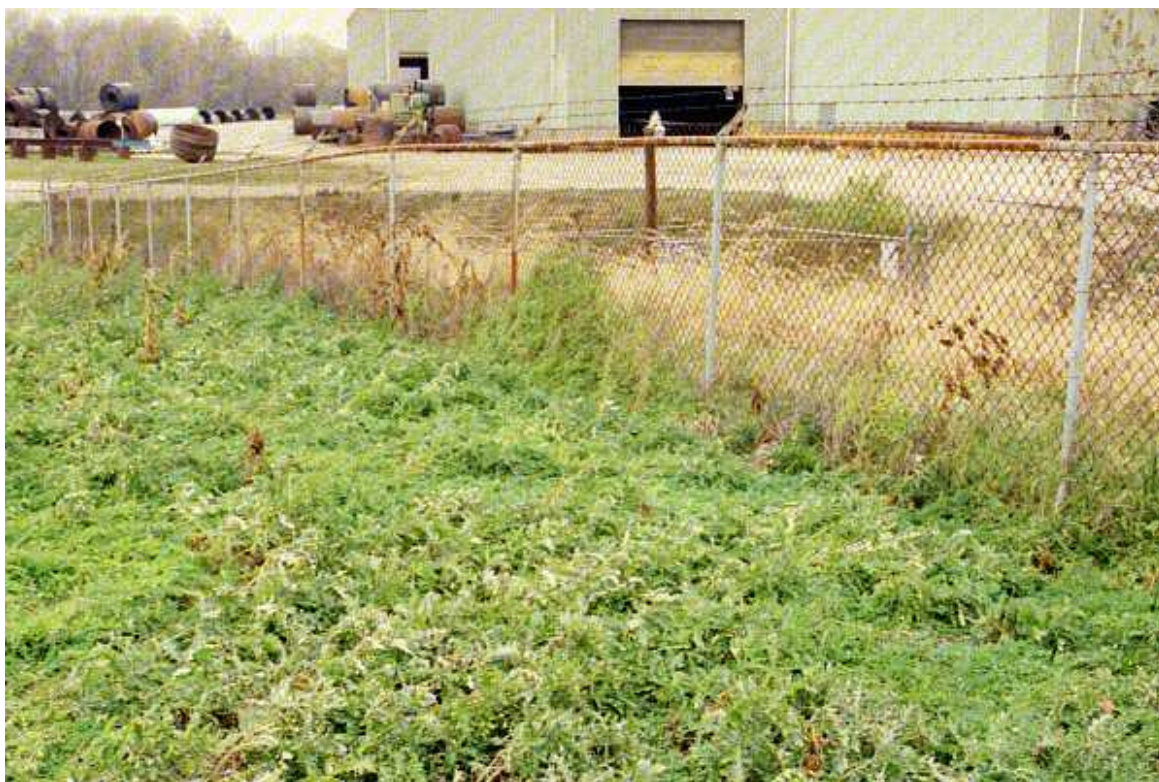
In 2000, several additional patches of thistle (identified in the field as Canada thistle) were observed between perimeter signs P2 and P6 (PL-4 and PL-6). Thistle in these areas appears to be spreading and should be specifically targeted for control during the 2002 maintenance season.

PL 4. Vegetation along security fence near perimeter sign P6. Note patch of thistle in foreground.

Recommendation: These patches of thistle should be specifically targeted for spraying during the 2002 maintenance season.

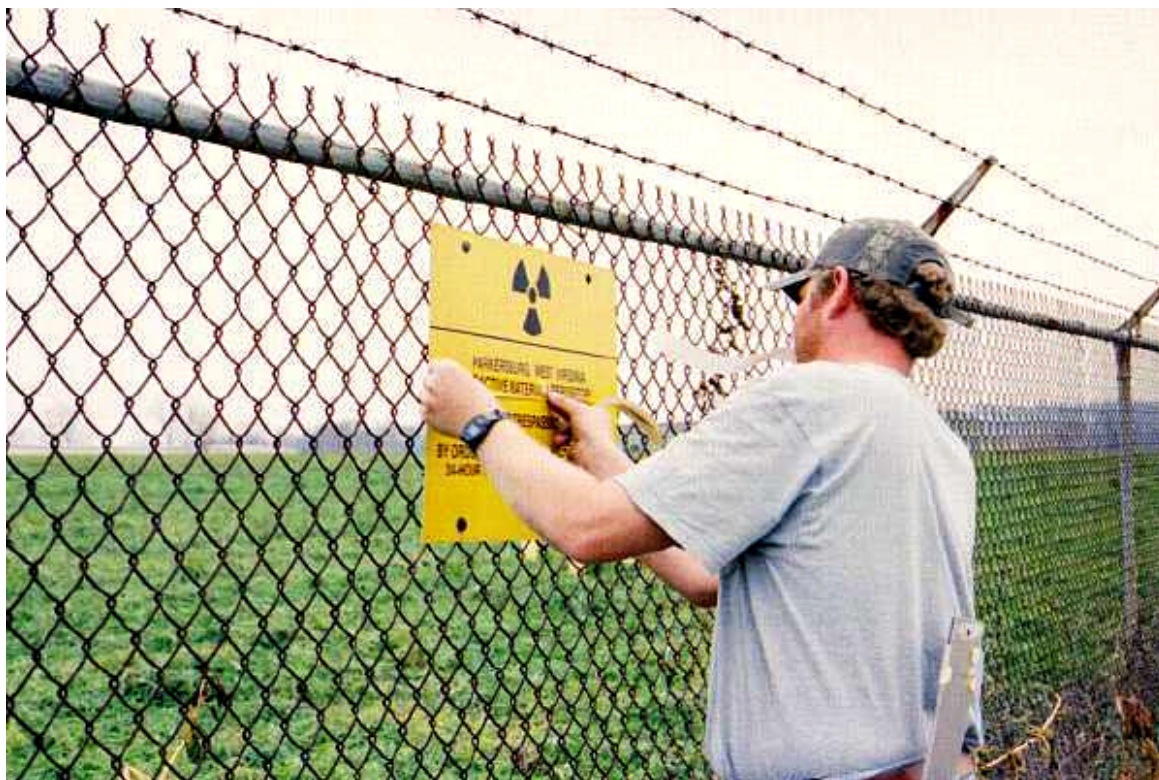
The entrance sign and all perimeter signs are in good condition. As noted during the 2000 site inspection, perimeter signs identified the waste material in the cell as "uranium mill tailings," which is an incorrect designation. Cell contents were derived from processing zirconium ore. Inspectors placed adhesive decals on each of the perimeter signs to correctly identify the waste as "Radioactive Materials" (PL-5).

PL 6. Inspector placing adhesive "Radioactive Materials" label on perimeter sign.

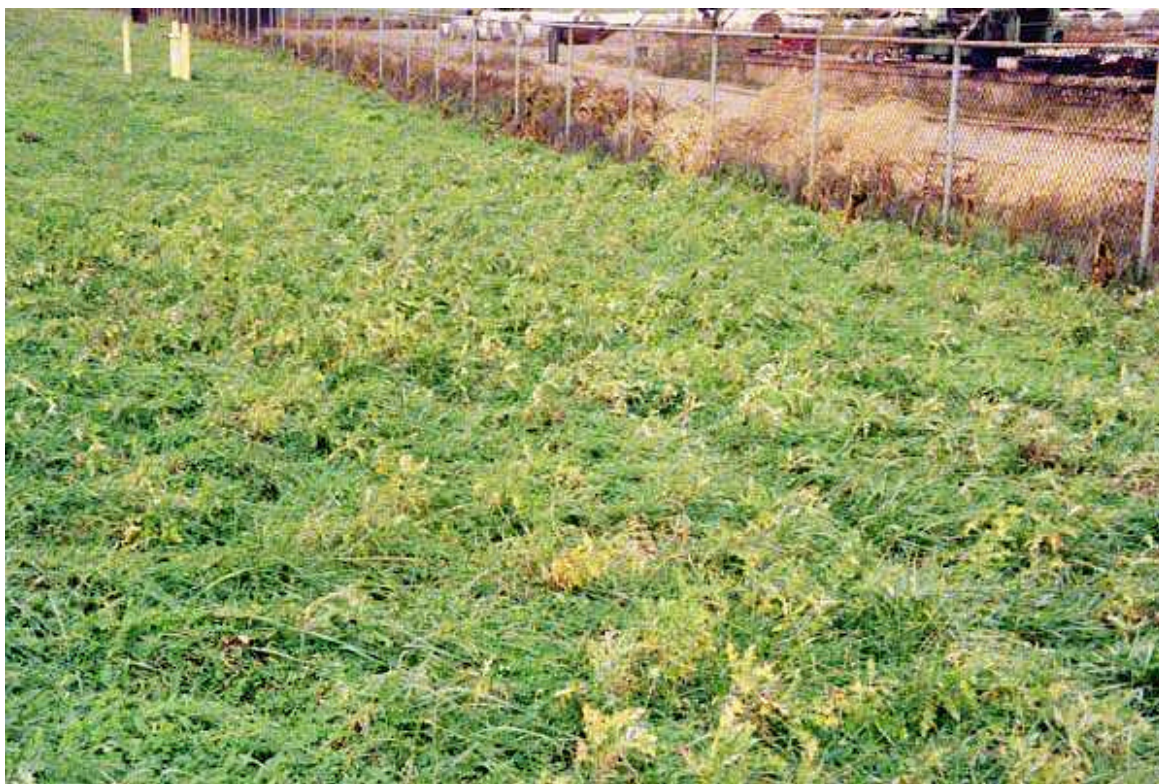
PL 5. Patch of thistle near perimeter sign P3.
